PROJECT:

DOLLAHAN ELEMENTARY

RIALTO, CA - PRIMARY

ALEX BERON
APRIL 29, 2021
DRAWING #
C20122CH

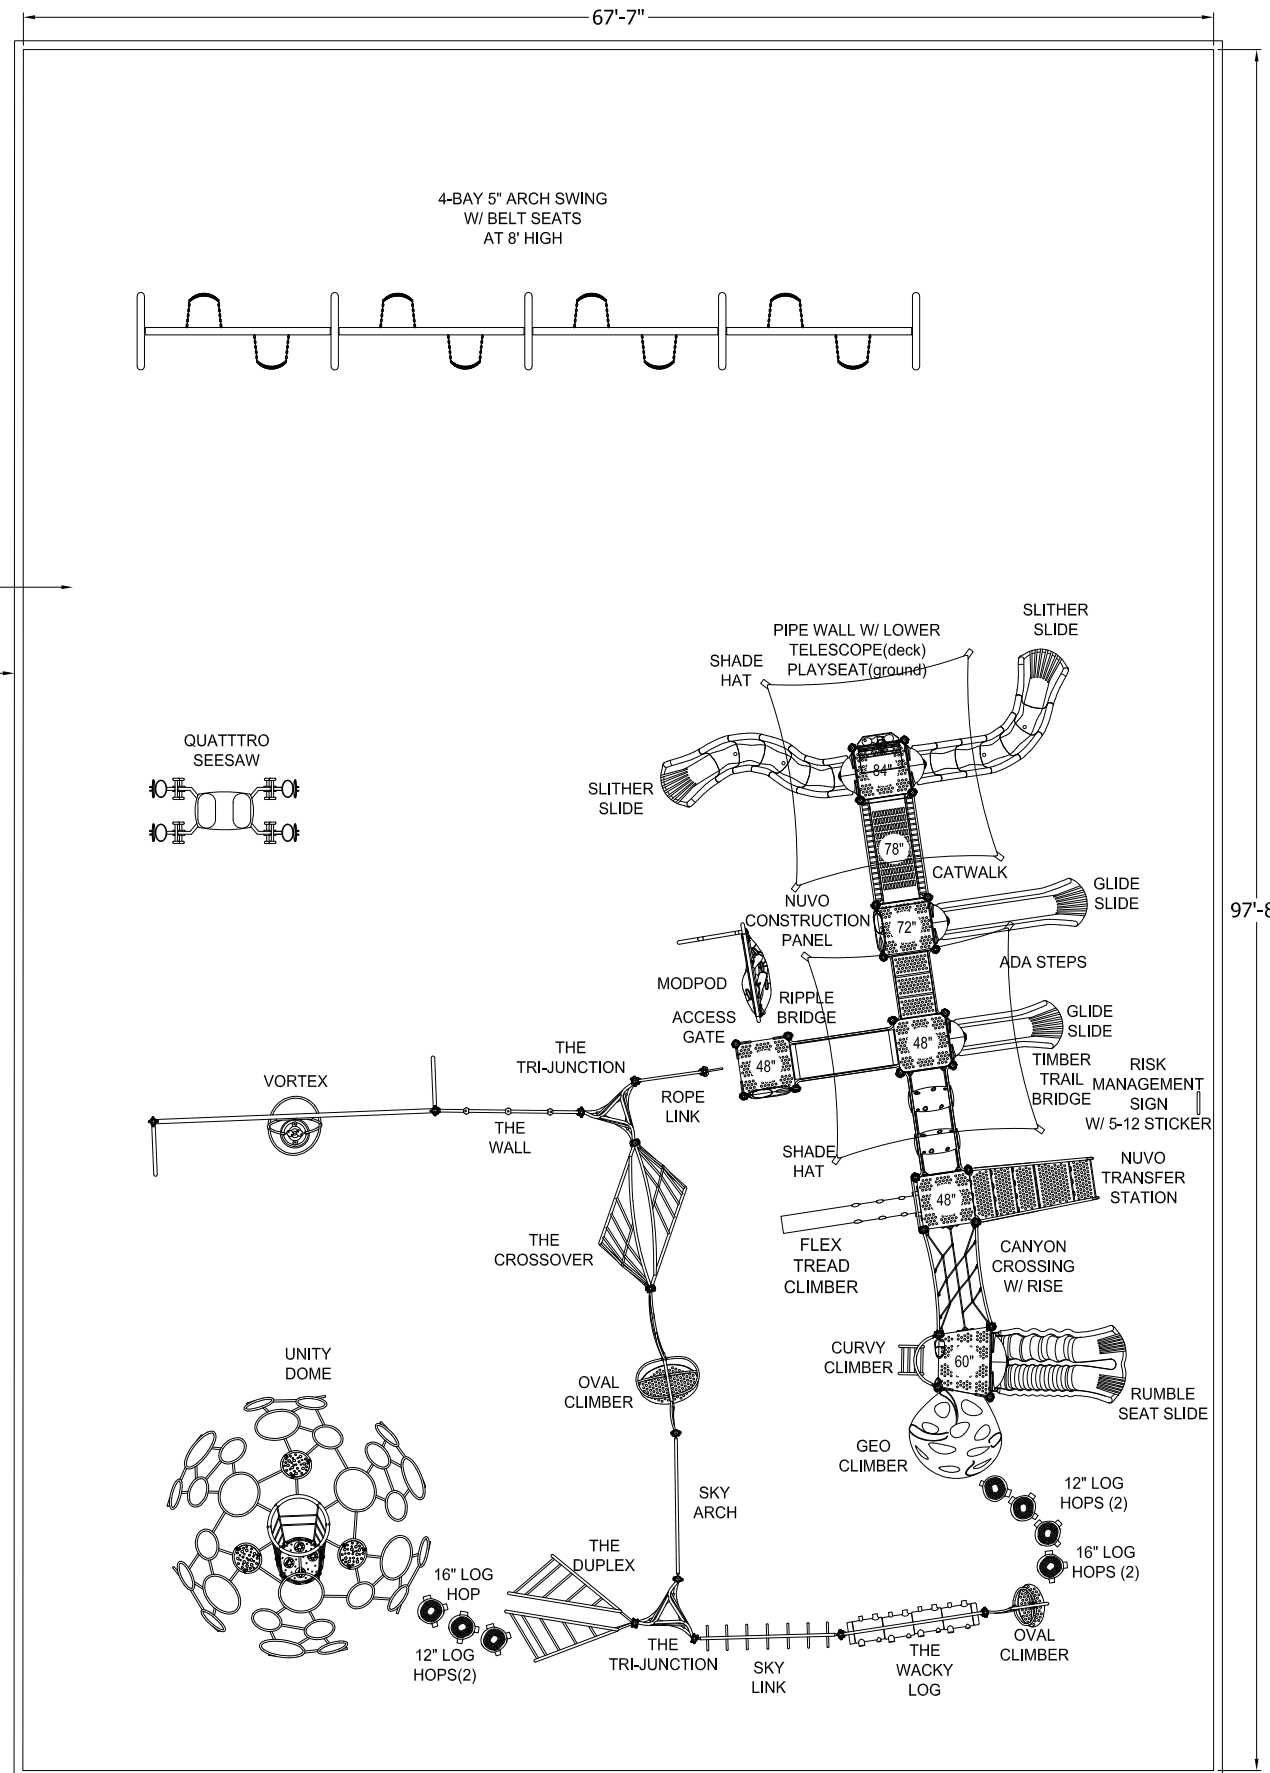
POURED IN PLACE RUBBER SURFACING
6600 SQ FT
CONCRETE CURB
330 LIN FT

TOTAL ELEVATED PLAY COMPONENTS:	17	REQUIRED:	0
TOTAL ELEVATED PLAY COMPONENTS ACCESSIBLE BY RAMP:	0	REQUIRED:	0
TOTAL ELEVATED PLAY COMPONENTS ACCESSIBLE BY TRANSFER:	17	REQUIRED:	8
TOTAL ACCESSIBLE GROUND LEVEL COMPONENTS SHOWN:	22	REQUIRED:	6
TOTAL ACCESSIBLE GROUND LEVEL COMPONENTS OF DIFFERENT TYPES:	8	REQUIRED:	3

PLAY STRUCTURE AND LAYOUT OF THE COMPONENTS CONFORM TO
ASTM F1487-17 AND CPSC #325 GUIDELINES AND CCR TITLE 22,
DIVISION 4 CHAPTER 22.

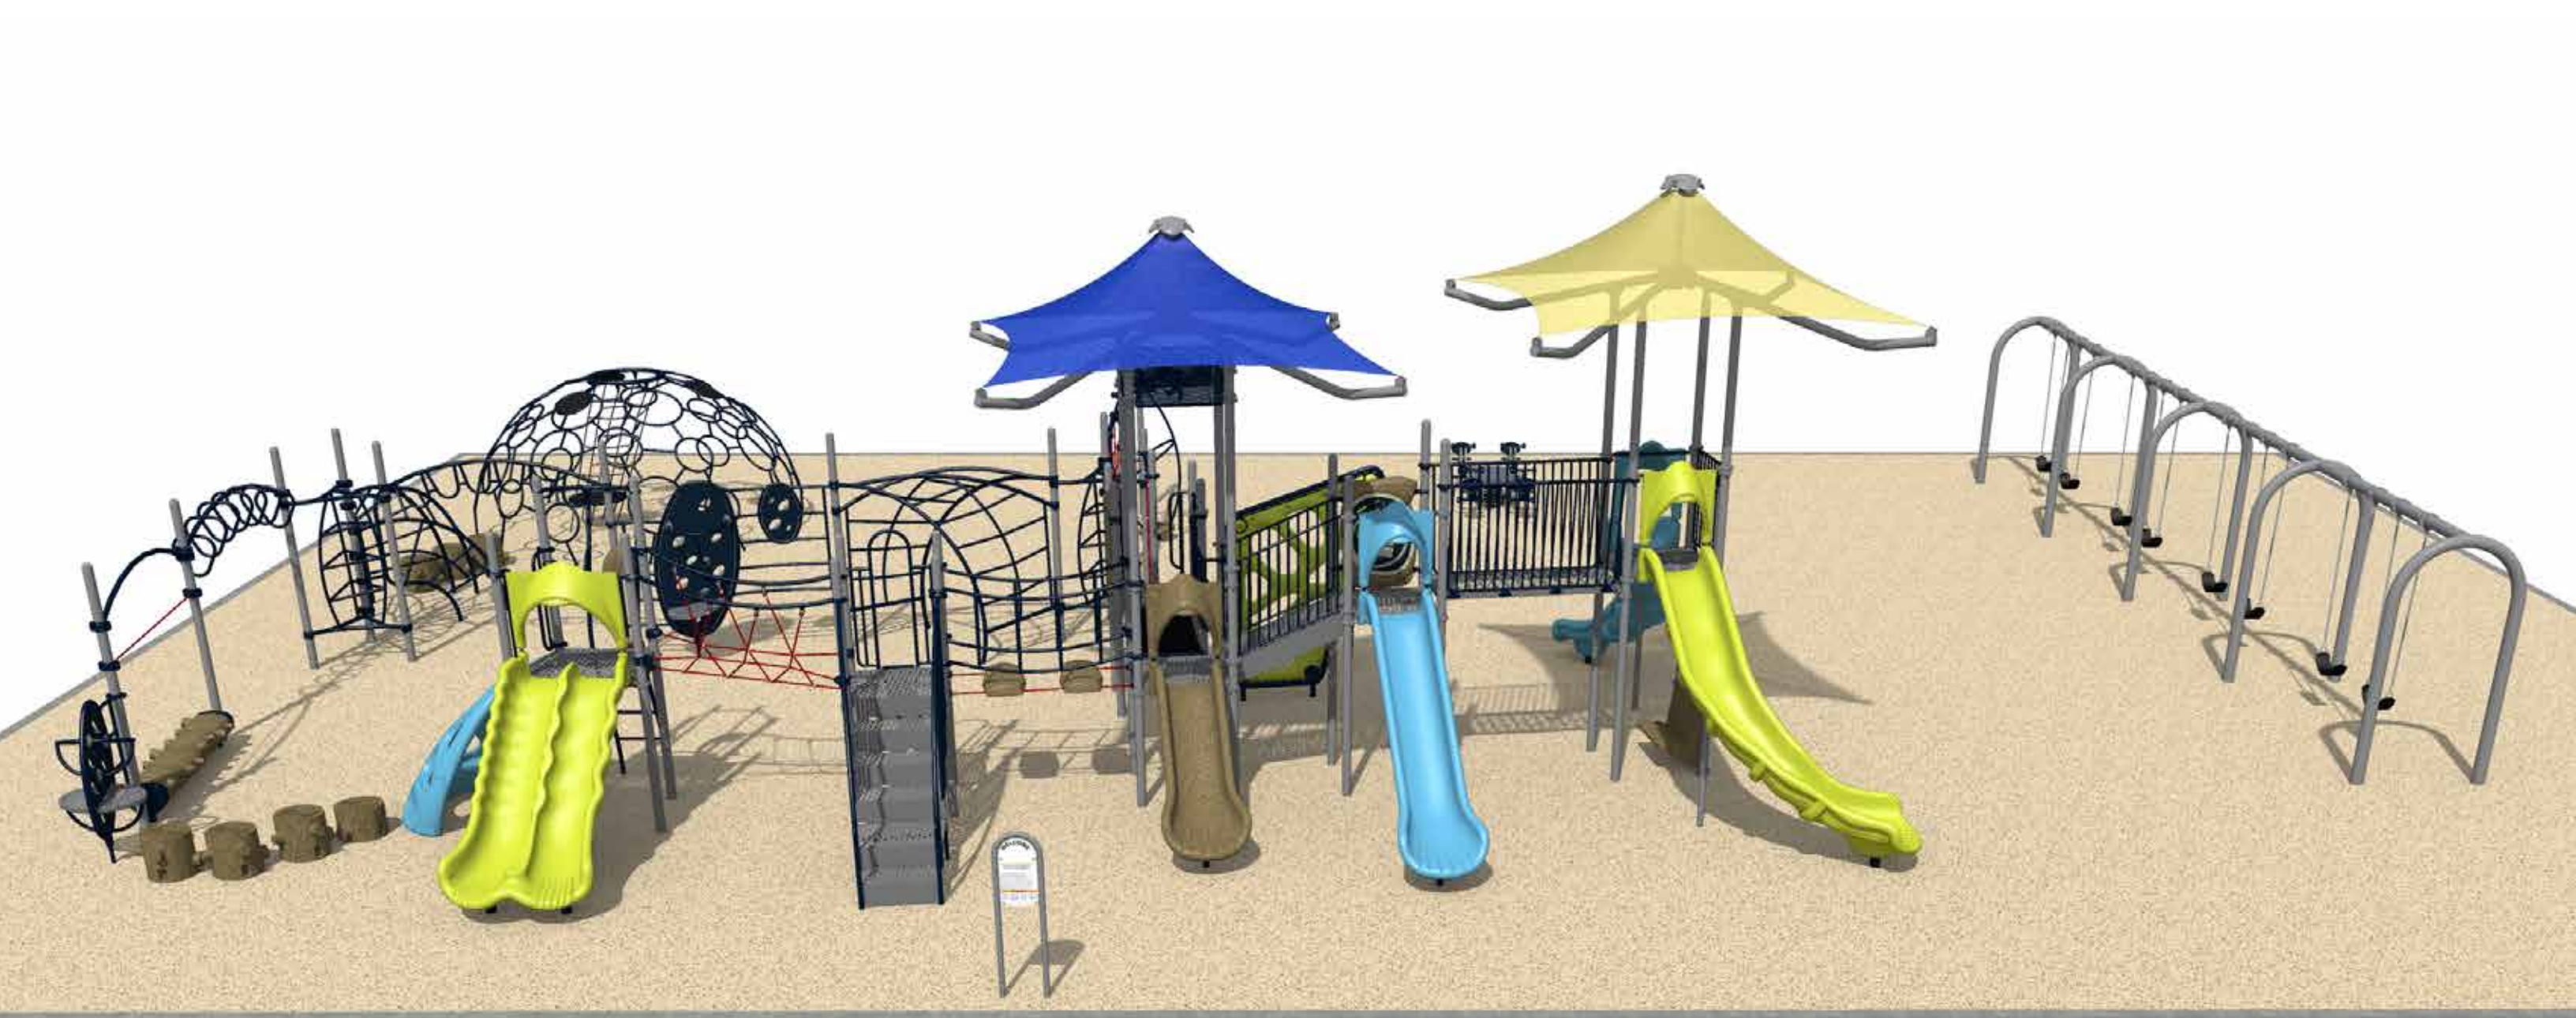
DOLLAHAN ELEMENTARY
RIALTO, CA - PRIMARY
