**SAN SALVADOR PRESCHOOL**  
COLTON, CA

ALEX BERON  
MAY 4, 2021  
DRAWING #  
**C22230CH**

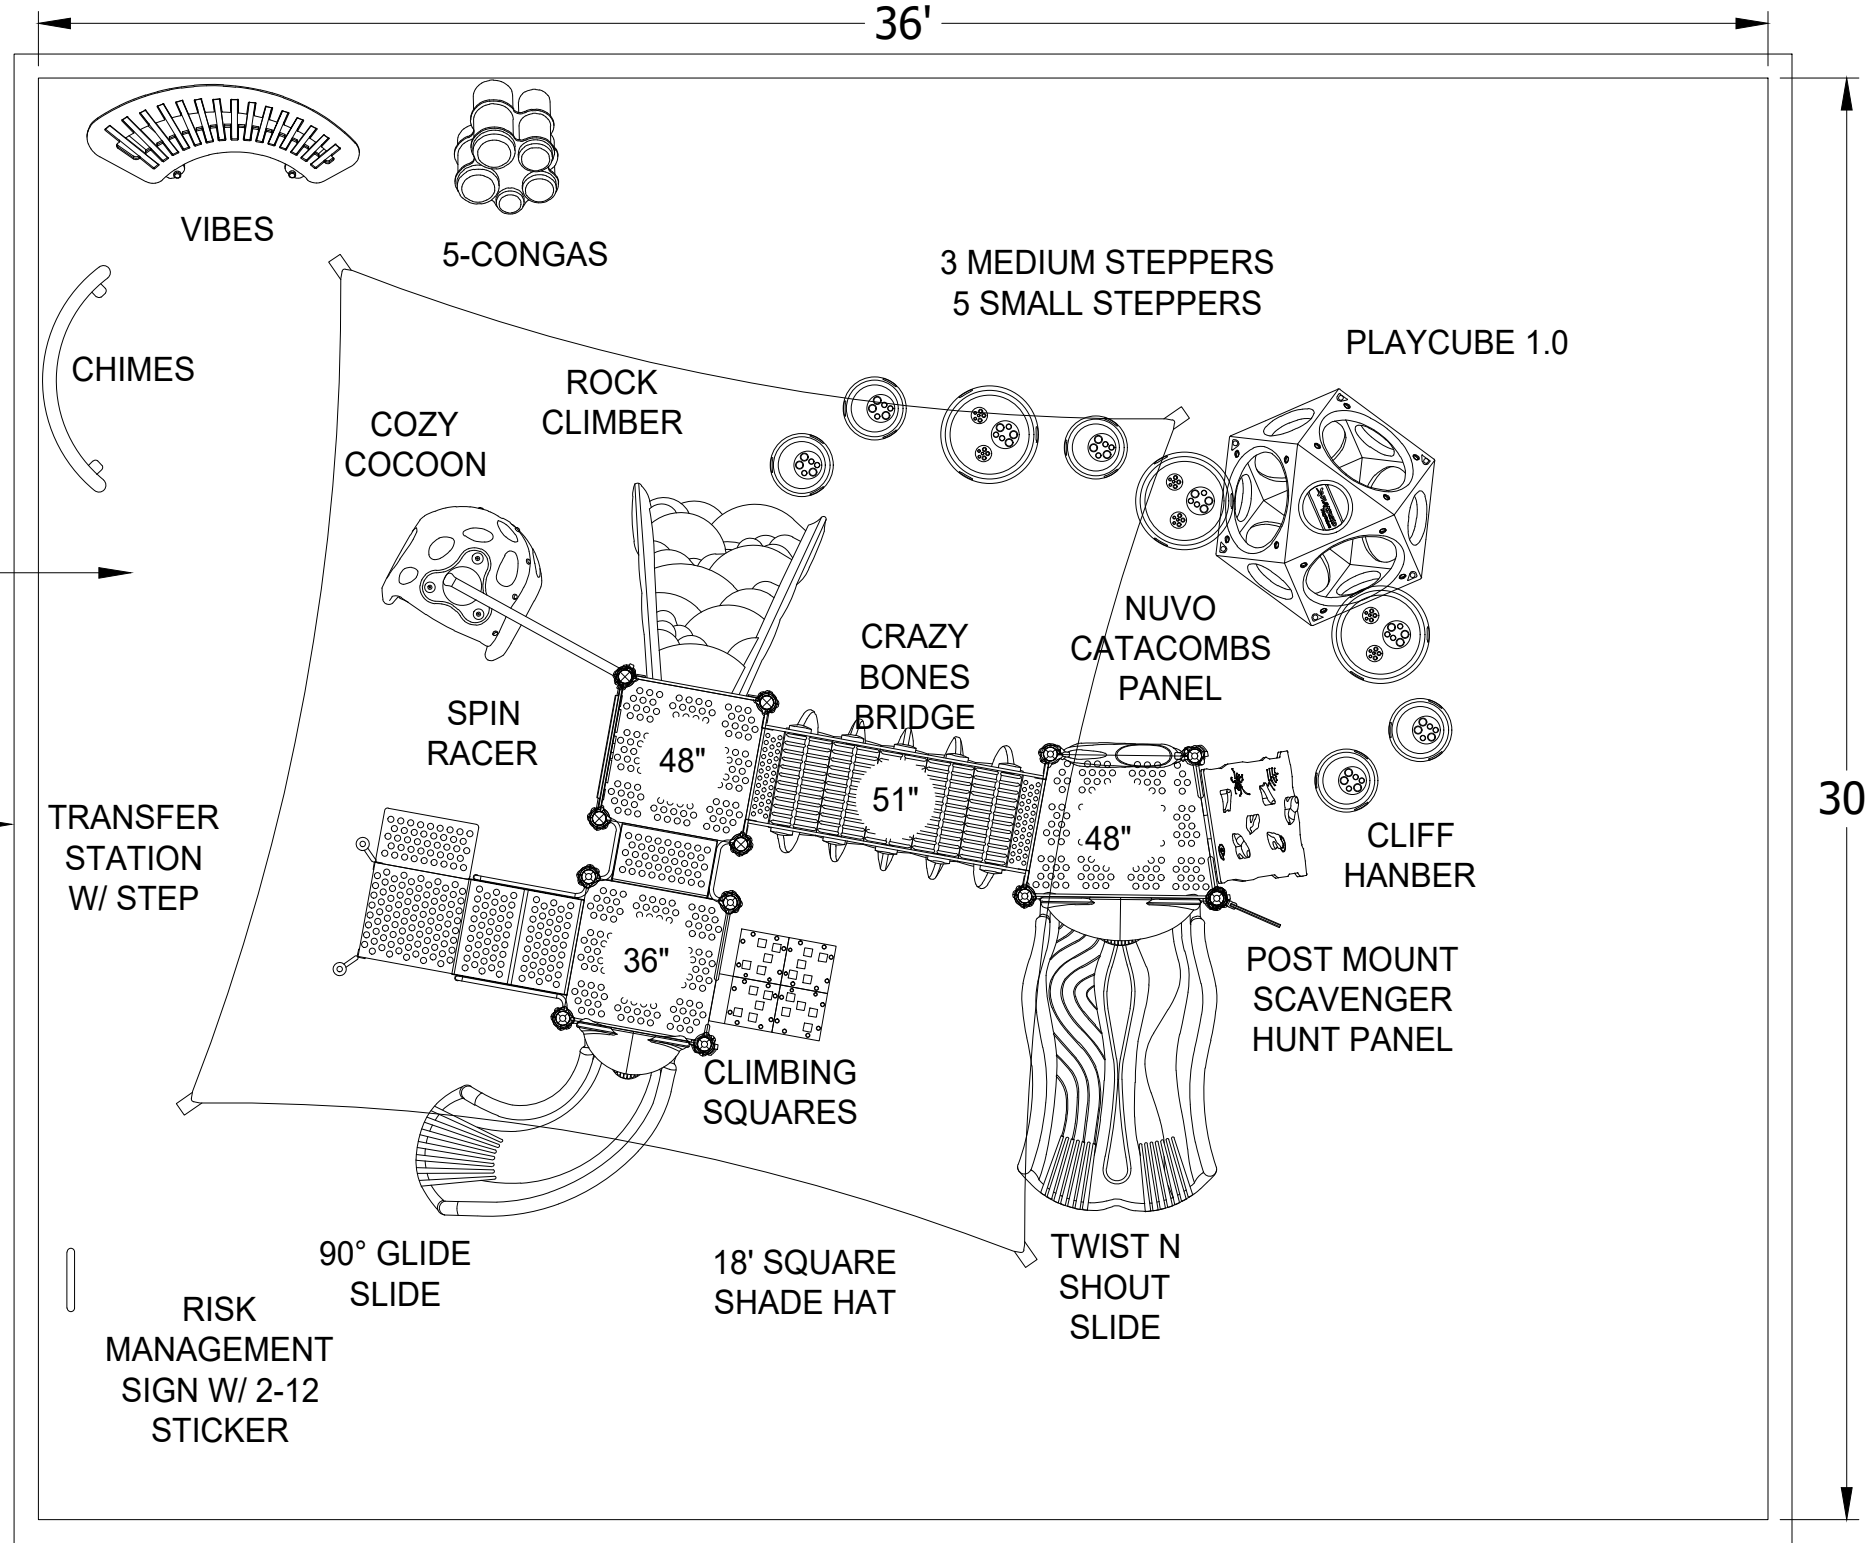
POURED IN PLACE  
RUBBER SURFACING  
1080 SQ FT

CONCRETE CURB  
132 LIN FT

TOTAL ELEVATED PLAY COMPONENTS:	8	REQUIRED:	0
TOTAL ELEVATED PLAY COMPONENTS ACCESSIBLE BY RAMP:	0	REQUIRED:	0
TOTAL ELEVATED PLAY COMPONENTS ACCESSIBLE BY TRANSFER:	6	REQUIRED:	4
TOTAL ACCESSIBLE GROUND LEVEL COMPONENTS SHOWN:	14	REQUIRED:	3
TOTAL ACCESSIBLE GROUND LEVEL COMPONENTS OF DIFFERENT TYPES:	5	REQUIRED:	3

PLAY STRUCTURE AND LAYOUT OF THE COMPONENTS CONFORM TO  
ASTM F1487-17 AND CPSC #325 GUIDELINES AND CCR TITLE 22,  
DIVISION 4 CHAPTER 22.

CRITICAL FALL HEIGHT OF OVERALL PLAY AREA: 51"
